Report No. 2433/3206/29
Date 24 MAR 1965

ADMIRALTY ENGINEERING
LABORATORY

EXPERIMENTAL THIN-PANELLED GLASS-FIBRE/RESIN CONTAINER
MADE BY PERMALI LTD. AND UNITED EBONITE & LORIVAL LTD.
FOR SUBMARINE CELL TYPE 8000 - SHOCK.

SUMMARY

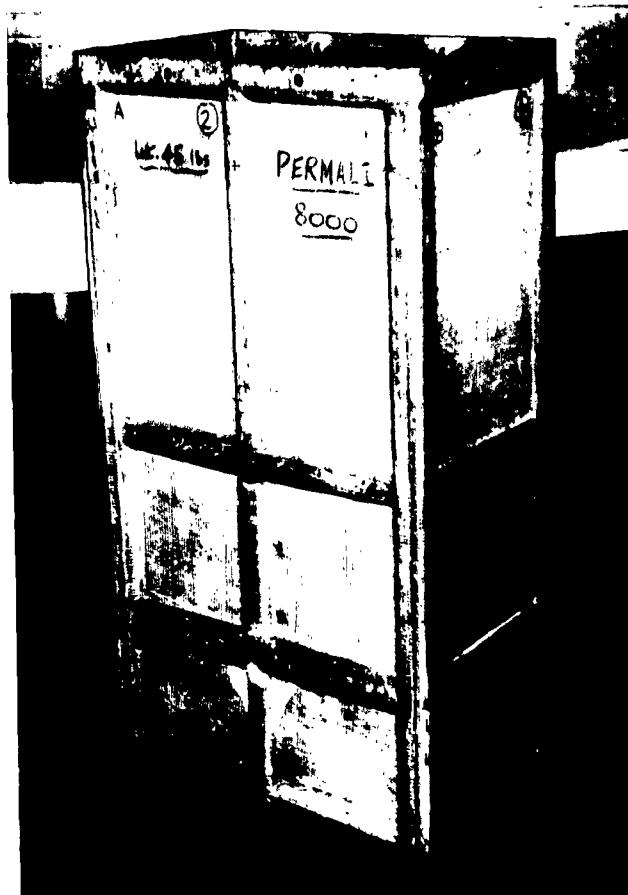
(a) General view of container.
